FINAL REPORT ON THE MANUFACTURE AND
STATIC FIRING OF X259-E6 ROCKET MOTOR
SERIAL NUMBER XJ04/0001

NASA Contract NAS1-10000-R80

Prepared by
D. Ray Robertson
Hercules Incorporated
Bacchus Works Magna, Utah

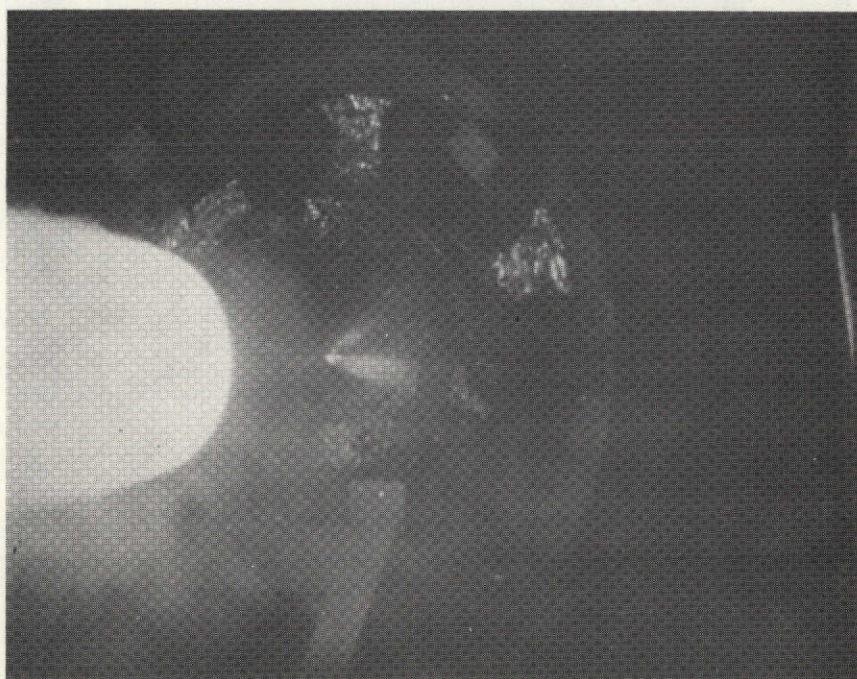
Figure 7. Appearance of Flame 0.4 Seconds After Figure 6 View. Taken From 400 Frames per Second Movie Film Located North-East of Motor

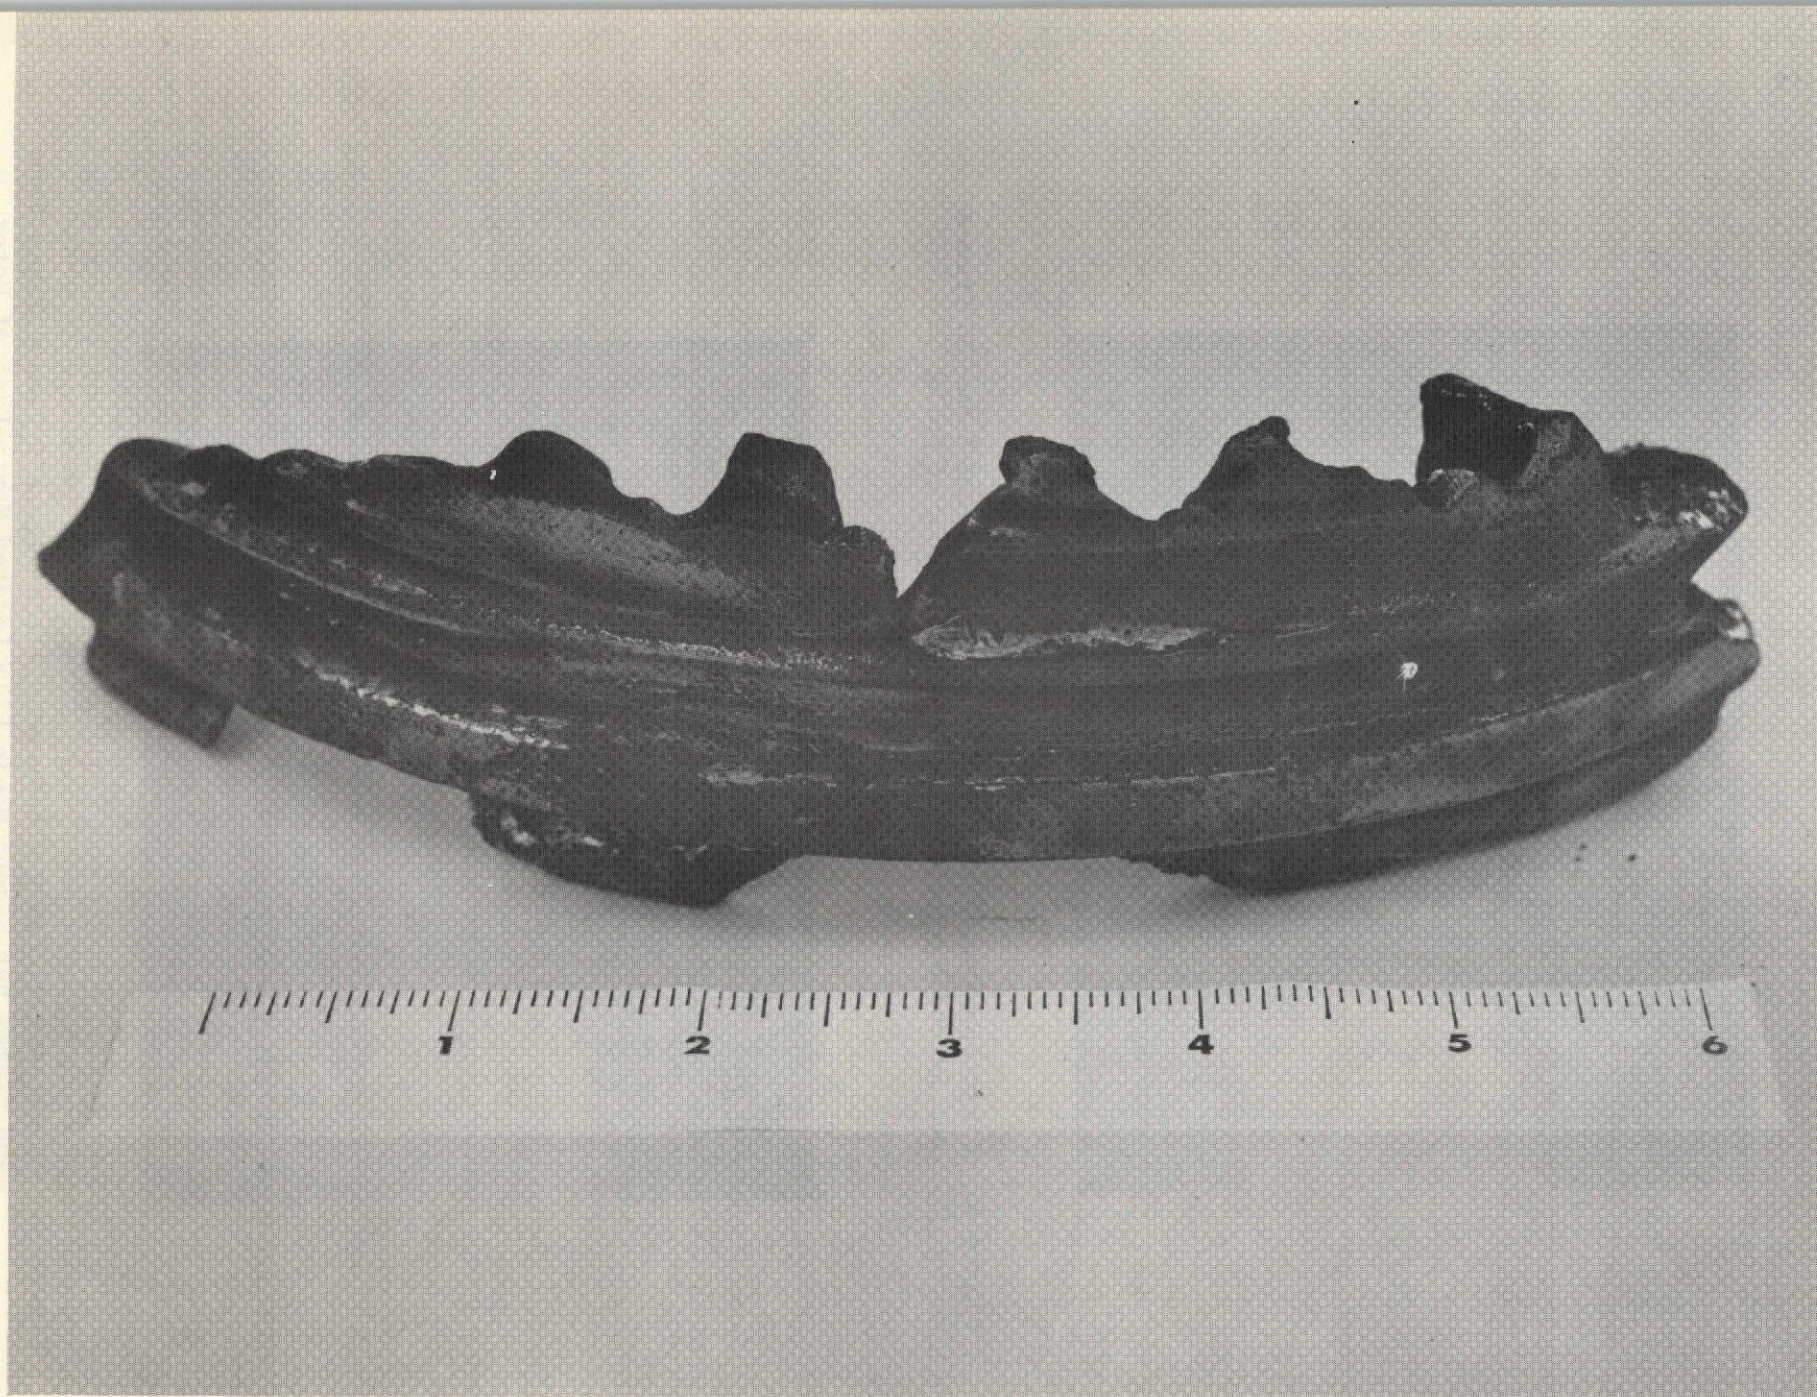
Figure 8. Retainer Ring Section (Showing O-ring Groove) Ejected From Motor at 29.4 Seconds

At 29.4 seconds, a rapid pressure drop occurred and a change in the plume shape was observed. The pressure drop from 200 psi (137.9 N/cm^2) to 70 psi (48.3 N/cm^2) corresponds to opening an additional area equal to the cross-sectional area of the retainer ring section expelled from the motor. (See Figure 8.) The side retainer ring vent area plus the throat area equals the area required to maintain a 70 psi (48.3 N/cm^2) motor pressure.

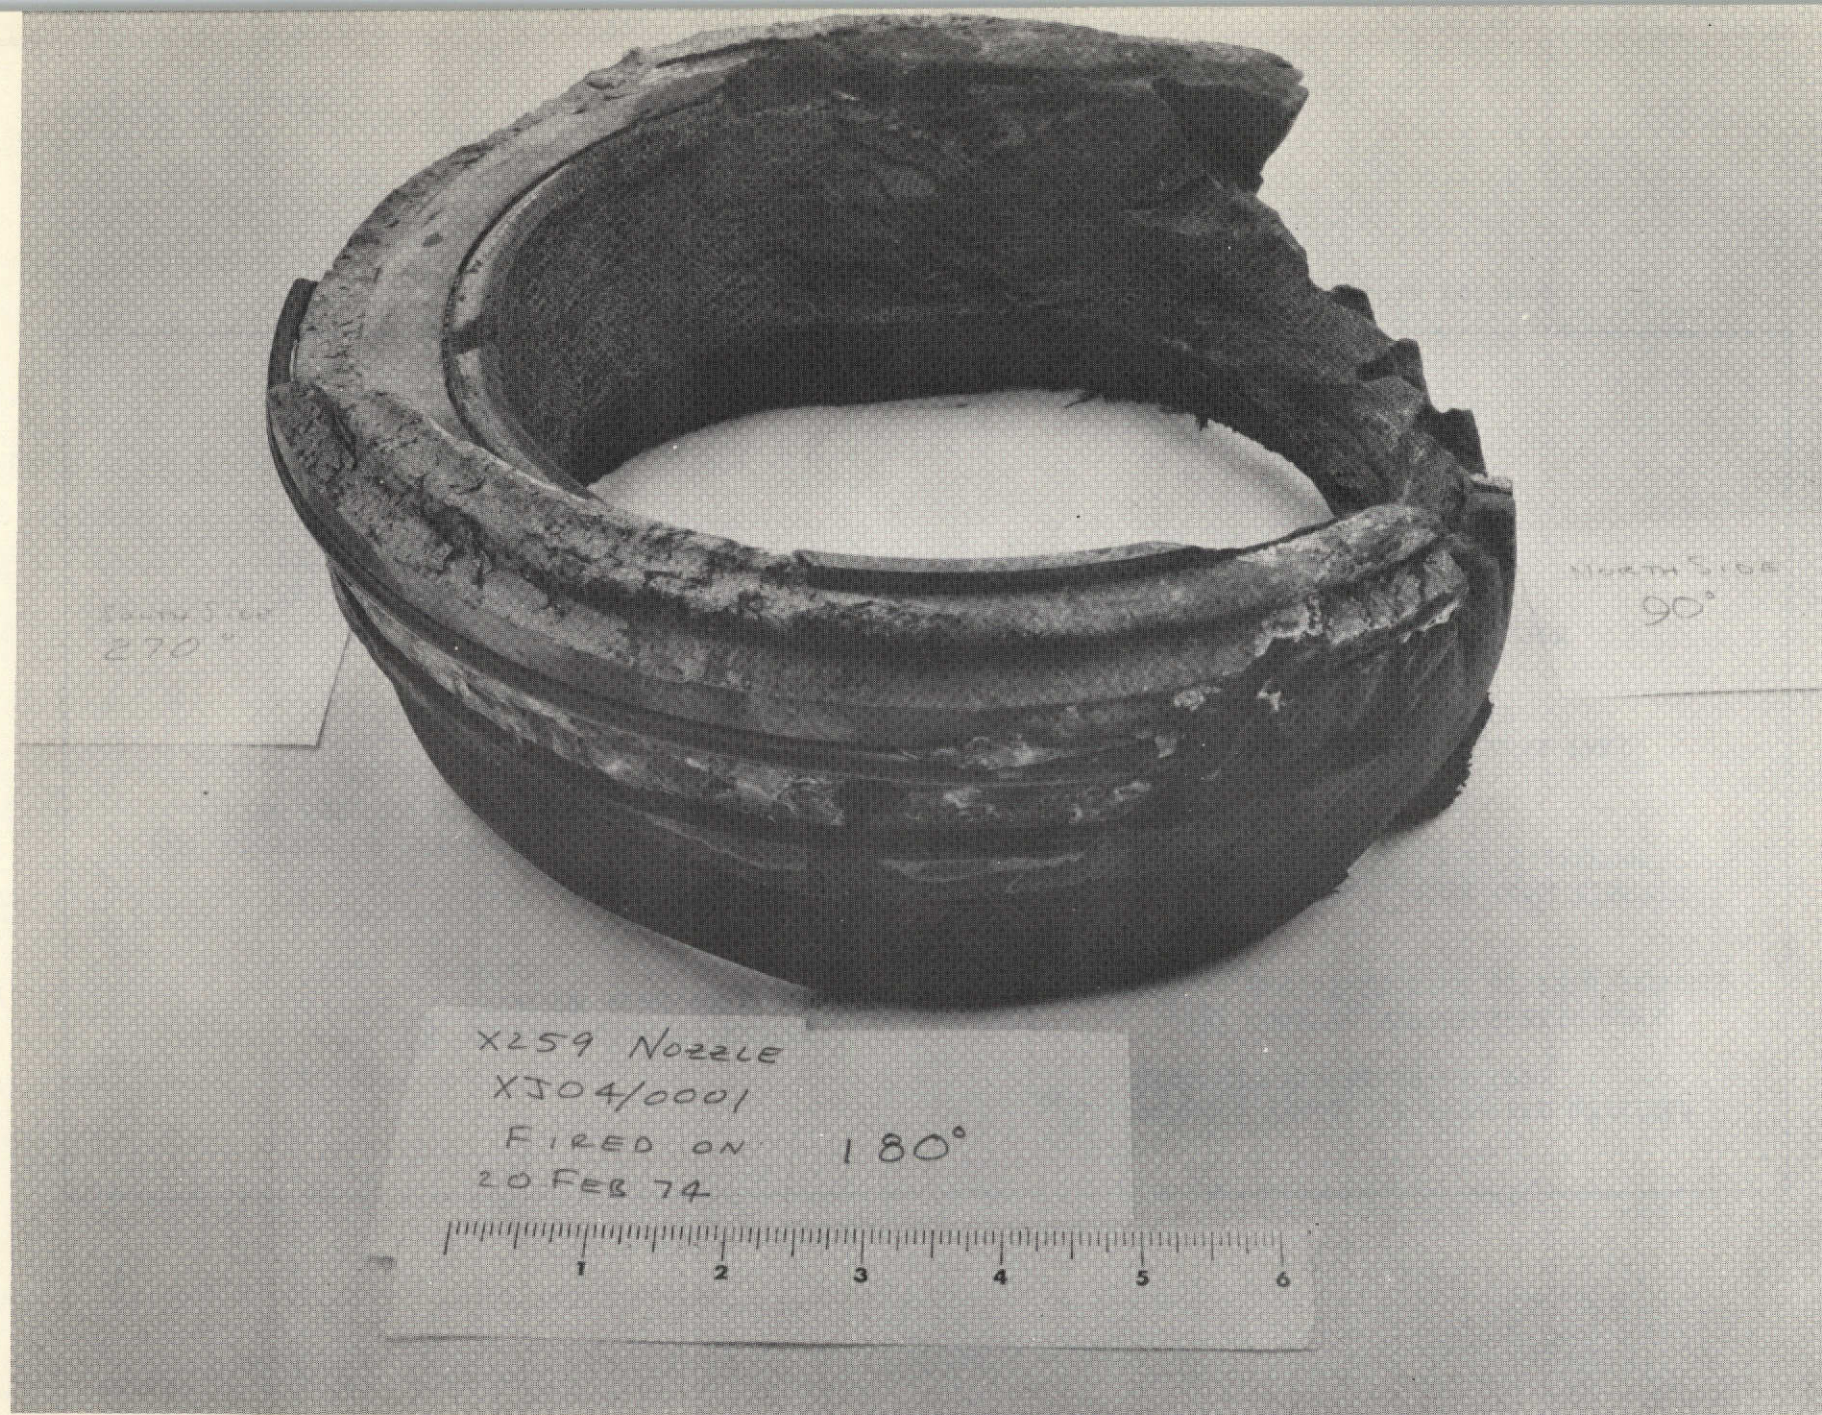
Figure 16. Nozzle Throat/Retainer Ring Assembly, 180° (3.14 rad) View

The retainer ring section was picked up 150 yards (137.16 m) northeast of the motor (the nozzle end of the motor faced east). The remaining throat/retaining ring assembly (Figure 16) was probably expelled at 38 seconds. As noted above, the motor pressure corresponds to ejection late in the firing. In addition, red streaks were seen in the movie film and a large red glowing object was seen by observers in the air at about 38 seconds. This assembly was found 250 yards (228.6 m) east-northeast from the motor.

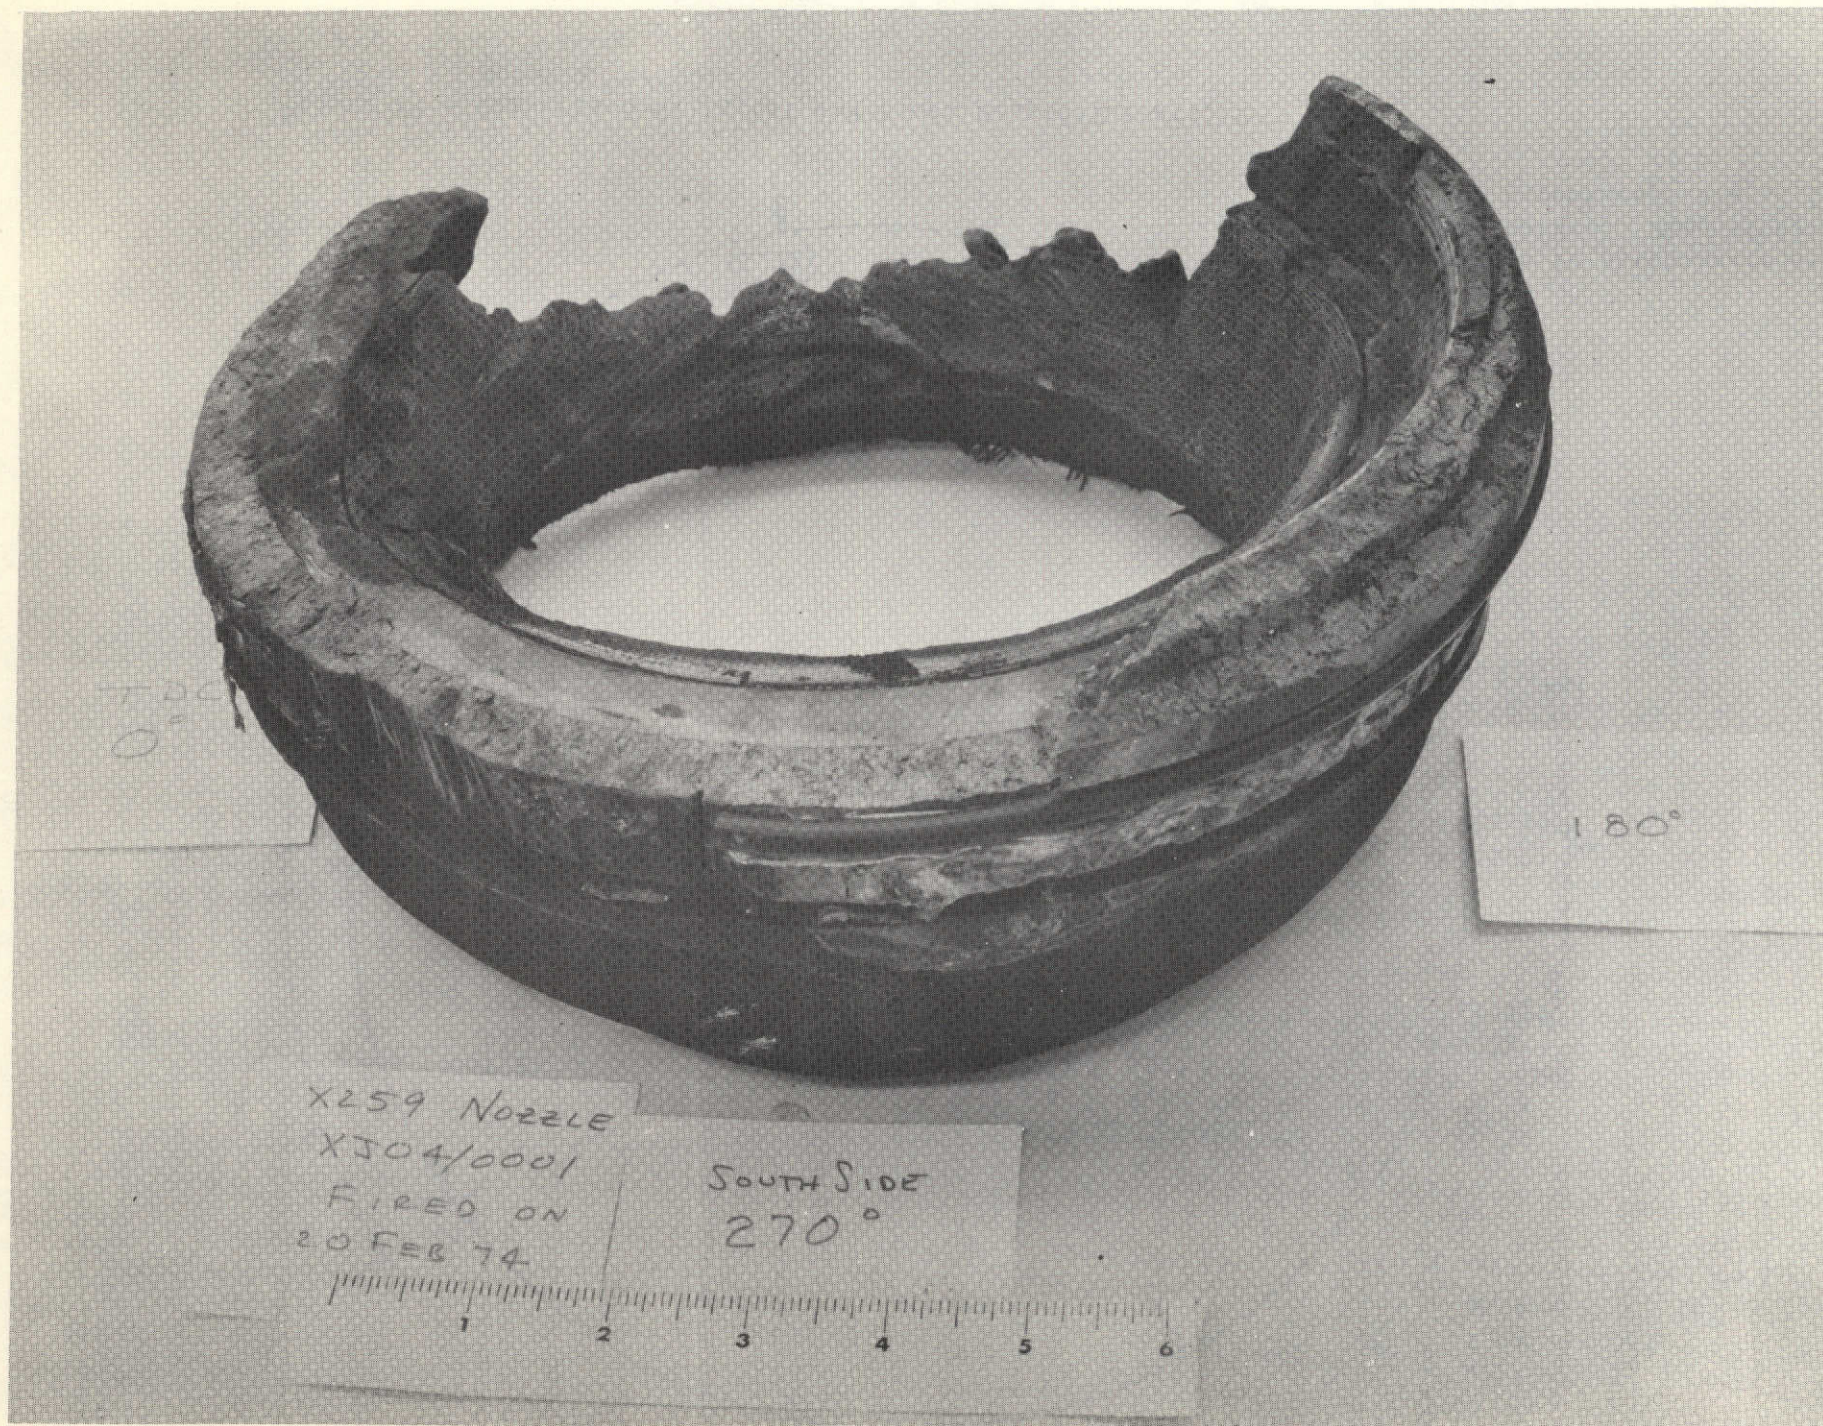
Figure 17. Nozzle Throat/Retainer Ring Assembly, 270° (4.71 rad) View

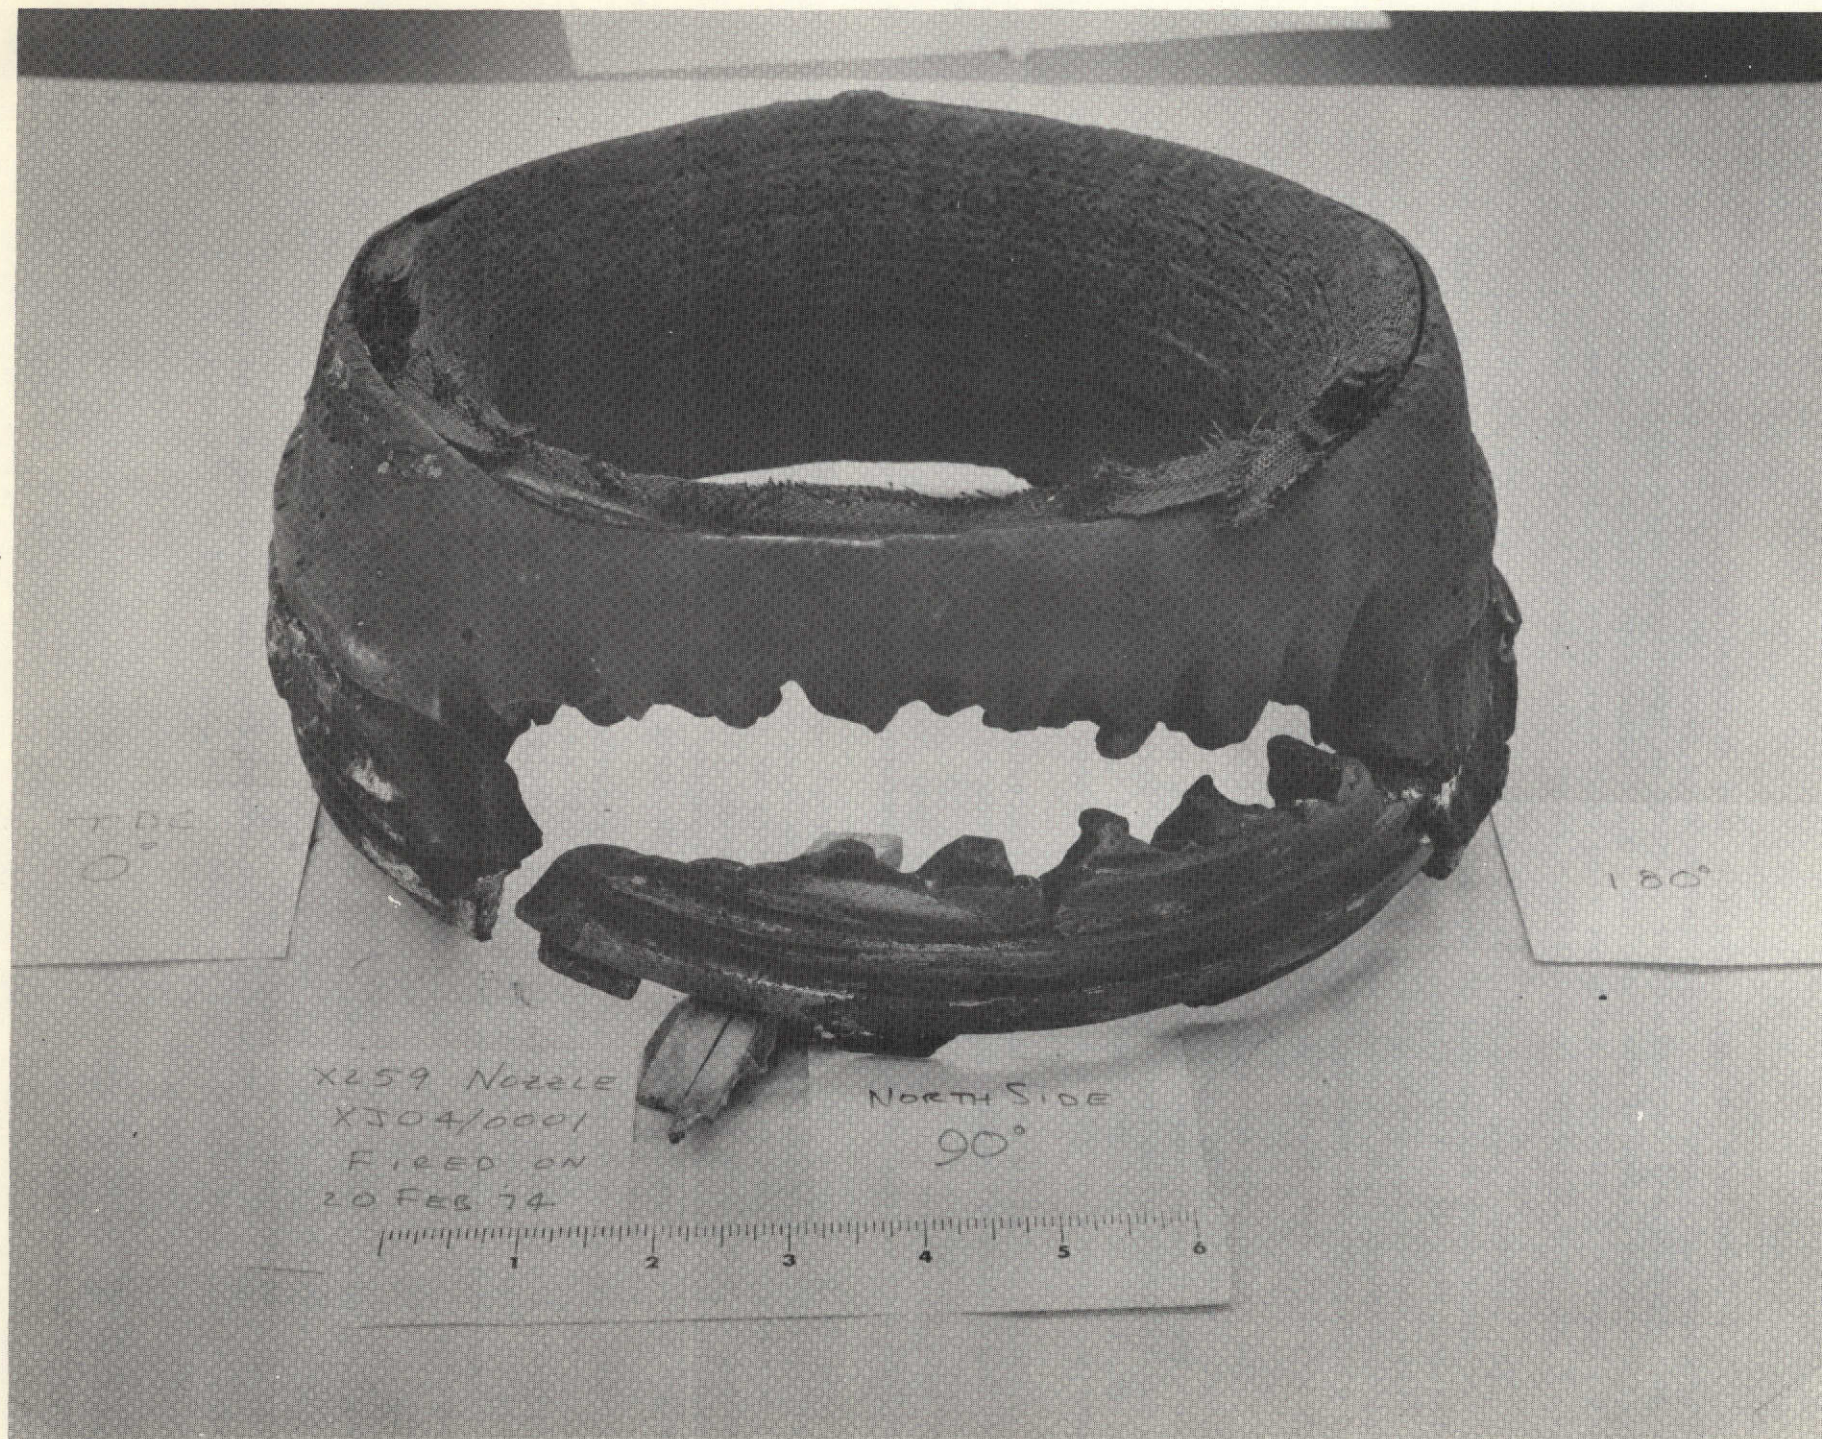
The ejection of the throat aft section and resultant flow across the exposed surface eventually would reveal the retainer ring 0.062 inch (0.16 cm) diameter vent holes. As these vent holes are opened, gas would start to flow through them. The velocity through these holes would initially be in the range of 1800 ft/sec (549 m/sec). From the erosion data of Figure 20, this started at about 16 seconds. The erosion opened up a leakage area of about 7 in.² (45.15 cm²) as shown in Figure 21.

Figure 21. Assembly of Retainer Ring Section and Nozzle Throat/Retainer Ring Assembly Showing Side Leakage Area

Gas leakage continues to erode the retainer ring vent holes. (See Figure 21.) The chamber pressure drops off as the vent holes grow. The retainer ring erosion ranges from 0.40 inch (1.02 cm) to 0.70 inch (1.78 cm) radially from the original vent holes. This implies erosion rates of 13.5 mils/sec (0.34 mm/sec) to 23.7 mils/sec (0.75 mm/sec) for a 29.4 second burn time, at which time a rapid pressure drop occurs. (See postulation 1, above.) These erosion rates seem too small for the exhaust eroding ability of the XLDB propellant used in motor XJ04/0001 when eroding a throat of RPD-150 asbestos/phenolic; therefore, leakage probably occurred over a shorter time period than 29.4 seconds.

- (1) Be leak-tested to verify that no leak paths exist
- (2) Have the vent holes in the exit cone liner checked for depth to assure that they are not too deep
- (3) Have nozzle throat and retainer ring bondlines radiographically inspected to assure adequate adhesive
- (4) Have vent holes in the retainer ring filled with adhesive to prevent a possible leak path
